ISTA: Release notes programming car 4.34.4x (ISTA/P 3.70.0)

Release notes

ISTA	4.xx
{ISTA Service Data}	4.34.40
ISTA/P	3.70.0

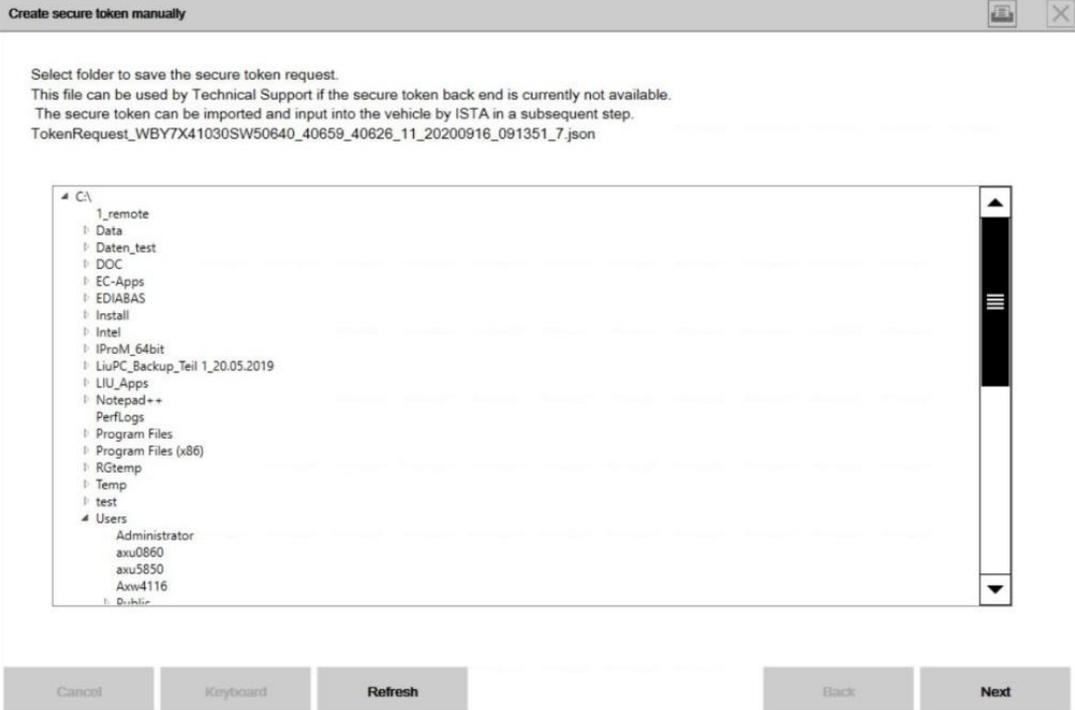
**Warning!**

Automatic Secure Token download not possible or failed.

Secure token download and activation after control unit exchange (SME) und (EME) und (CCU) is mandatory!

The next steps in the procedure are as follows:

- Continue with the manual generation of the secure token request file as part of this measures plan.

When you select the "OK" button, ISTA generates the required ZIP archive in the format(TokenRequest_VIN17_DealerData1_DealerData2_OutletNo_YYYYMMDD_HHMMSS.zip) and opens a file dialog for saving. This file must later be sent to technical support via PUMA or TSARA.
