# Release Notes Programming

## Passenger Cars

ISTA	4.27.1x
ISTA Service Data	4.27.11
ISTA/P	3.68.0

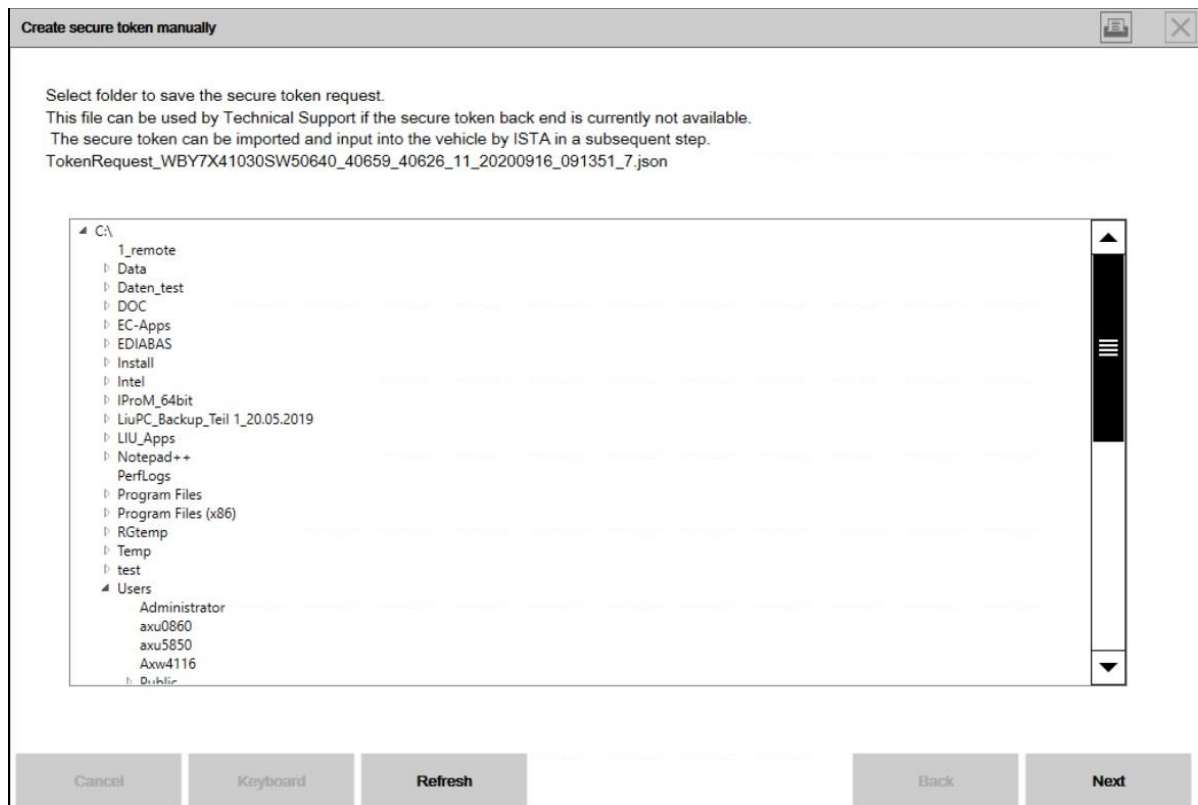
By clicking on the "OK" button, ISTA generates the required TokenRequest\_VIN\_xxx.json file and opens a file dialogue to save it. The file must be sent to technical support later via PuMA or TSARA.

The session can be terminated if necessary.

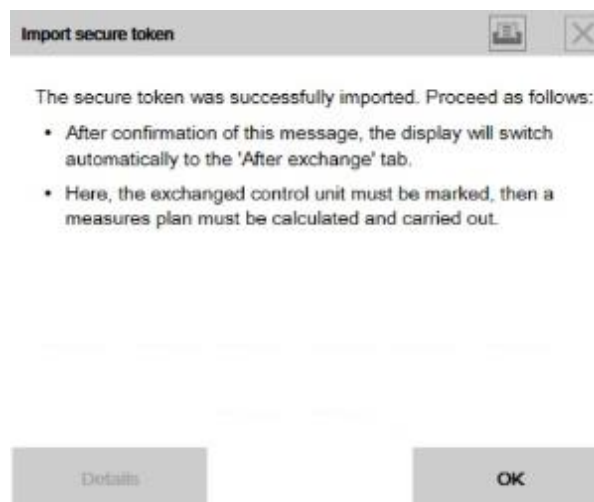
Select the TokenRequest\_VIN\_xxx\_response.json file in the file dialogue and confirm.

If the TokenRequest\_VIN\_xxx\_response.json file has been read successfully, ISTA automatically switches to the control unit exchange / after exchange tab.
